Construction Report

-Experimental Feature-

**Lumimark Traffic
Striping System**

Utah Department of Transportation
Research & Development Division

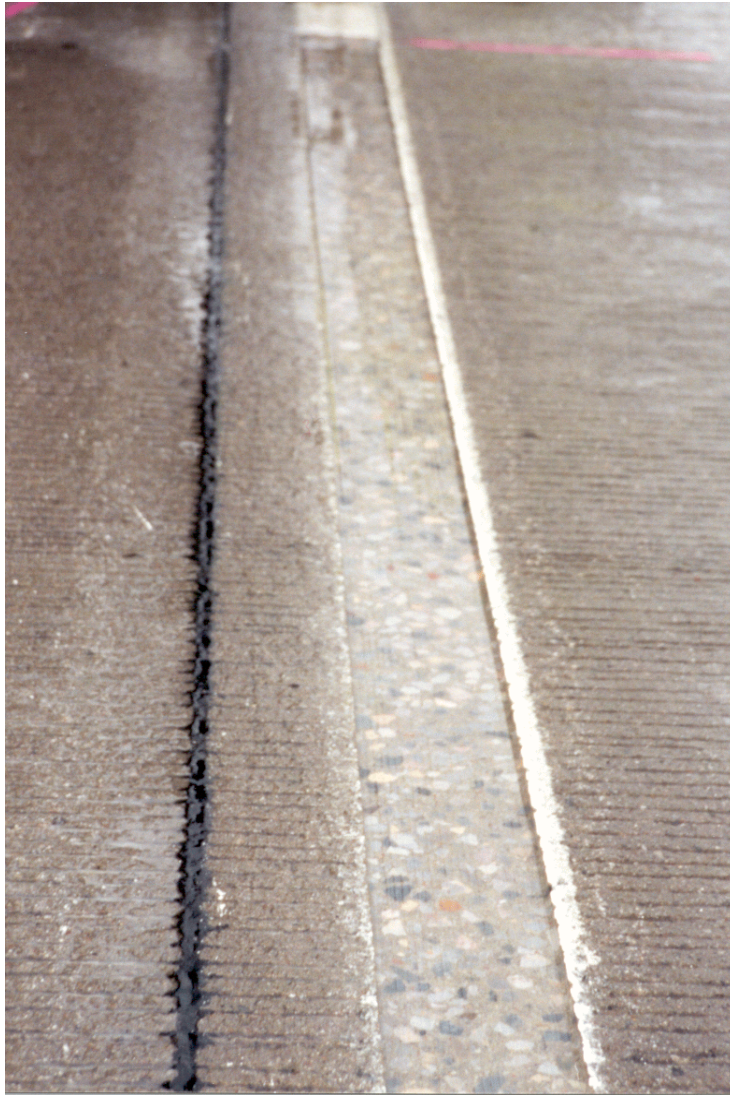
FIGURE 1. PCCP GROOVE

The Lumimark Traffic Striping System was installed in Region Two between August 28 and 29, 2000. Weather conditions were fair to partly cloudy with 70 °F ambient temperature during product installation. Crews begun cutting a 6.5 mm deep groove on top of the solid yellow outside shoulder line. The grooving tool left a clean, even cut on the concrete (See Figure 1). Surface preparation before product installation included washing with a high pressure water spray and blowing the water and any laitance with compressed air. The Lumimark surface material was installed using walk-behind portable equipment. The bagged material (with premixed glass beads) was mixed in the hopper and applied directly on the concrete groove. Additionally, Type 1 and 3 glass beads were sprinkled on the surface material during application through a gravity-fed funnel and finished by an air curtain. Following product installation, crews sprayed a liquid cure over the striping surface. Surface material cure time was approximately 1.5 to 2.0 hours under prevailing weather conditions. The ramp was reopened to traffic after a successful surface penetration test was performed by MBT. The following day, crews grooved the white skip and solid lines, cleaned the surface and completed product installation (See

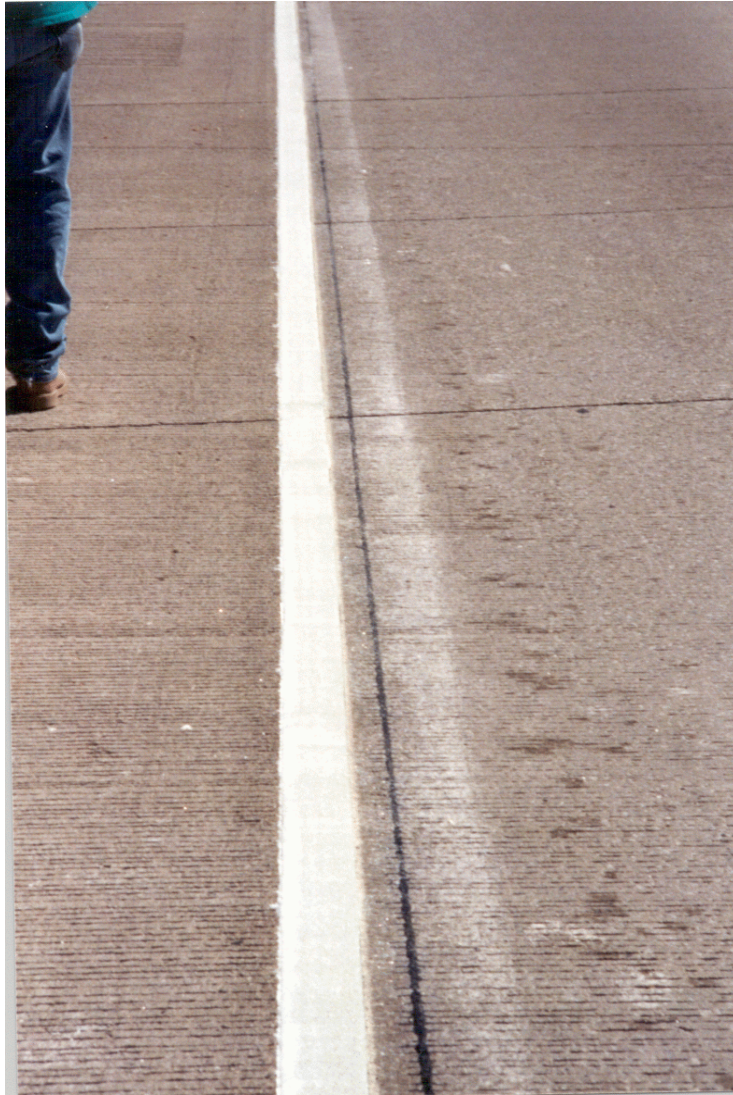
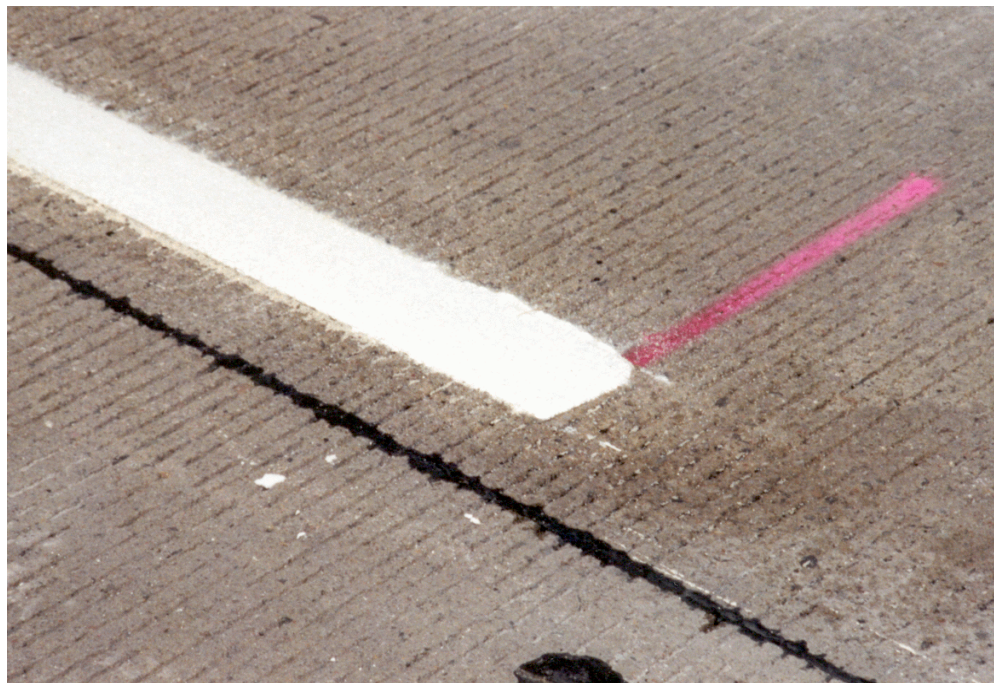
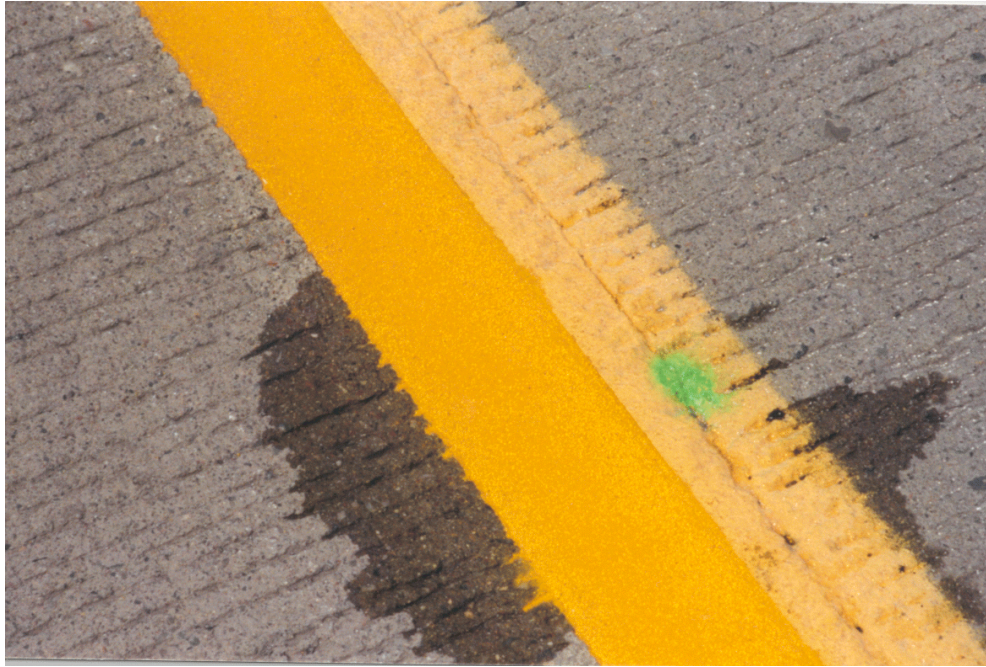
Figures 2 through 5).

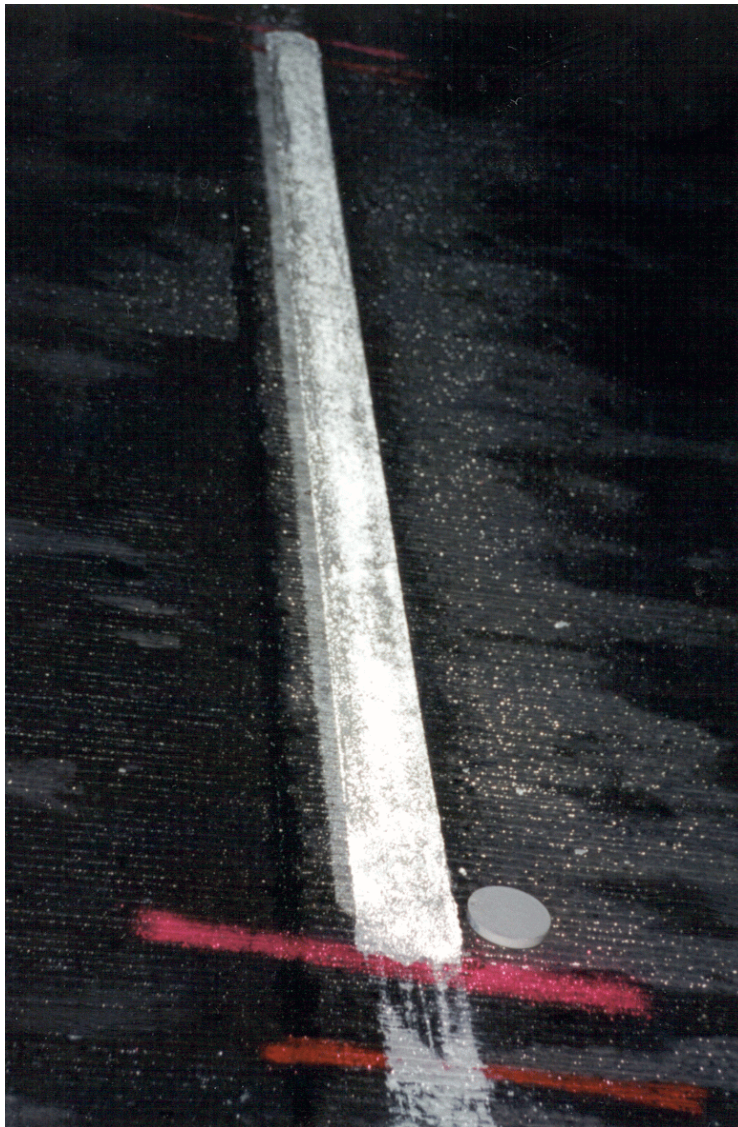
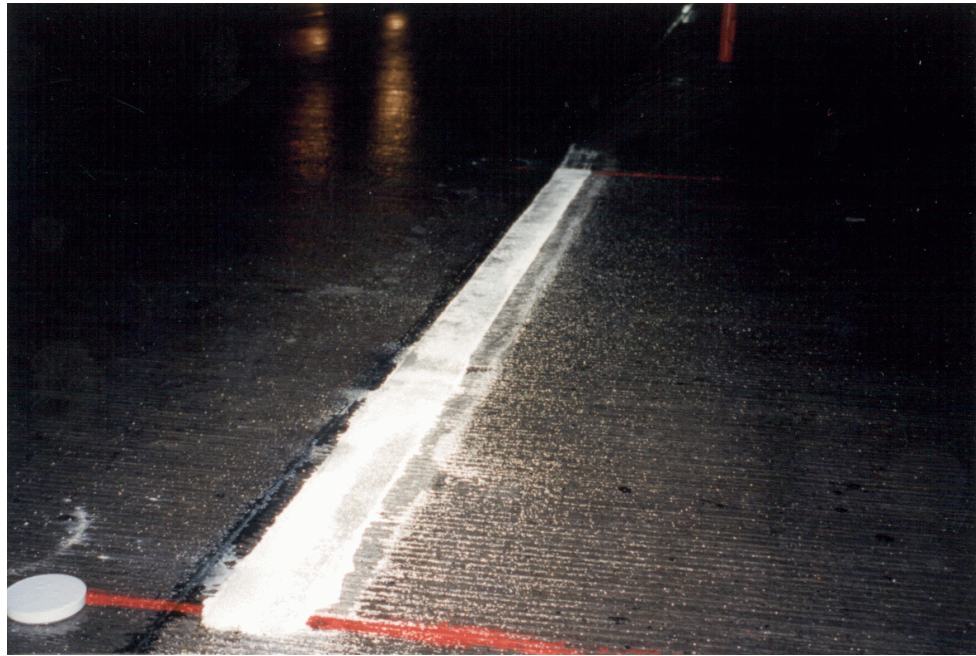
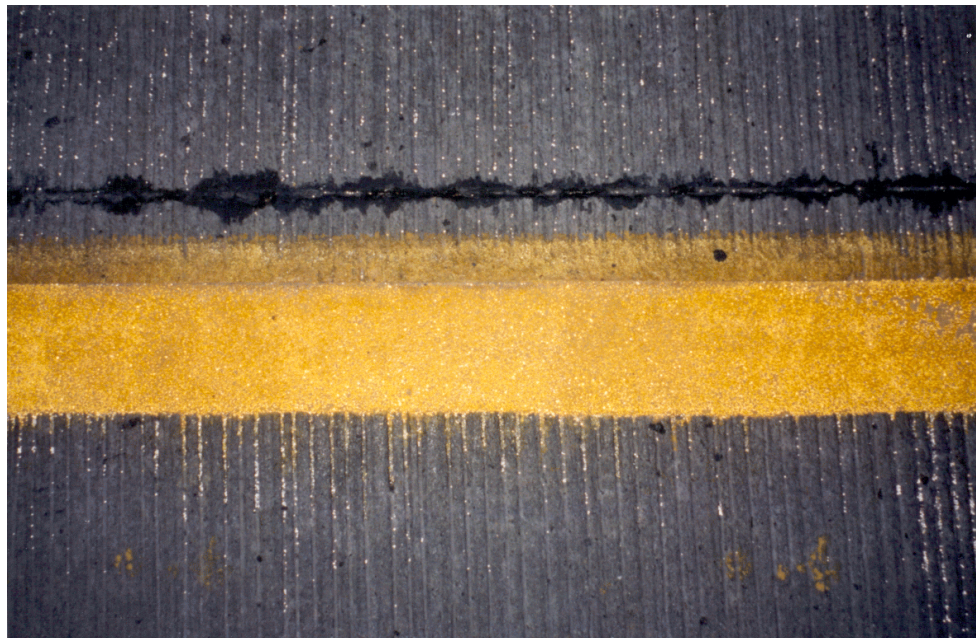
The Lumimark Traffic Striping System was installed in Region Three between August 29 and 31, 2000. Weather conditions were partly cloudy during the first night, and rainy during the second night (product installation took place during the night to avoid traffic congestion). During the night of the 29th, Crews begun cutting a 6.5 mm deep groove on top of the solid yellow turnaround lane line. The grooving tool left a clean, even cut on the concrete. Surface preparation before product installation included washing with a high pressure water spray and blowing the water and any laitance with compressed air. The Lumimark surface material was installed using walk-behind portable equipment. The bagged material (with premixed glass beads) was mixed in the hopper and applied directly on the concrete groove. Additionally, Type 1 & 3 glass beads were sprinkled on the surface material during application through a gravity-fed funnel and finished by an air curtain. Following product installation, crews sprayed a liquid cure over the striping surface. The following night, crews completed the grooving operation by removing the skip white striping on both lanes of the road after which the white surface material was placed (See Figures 6 through 8).

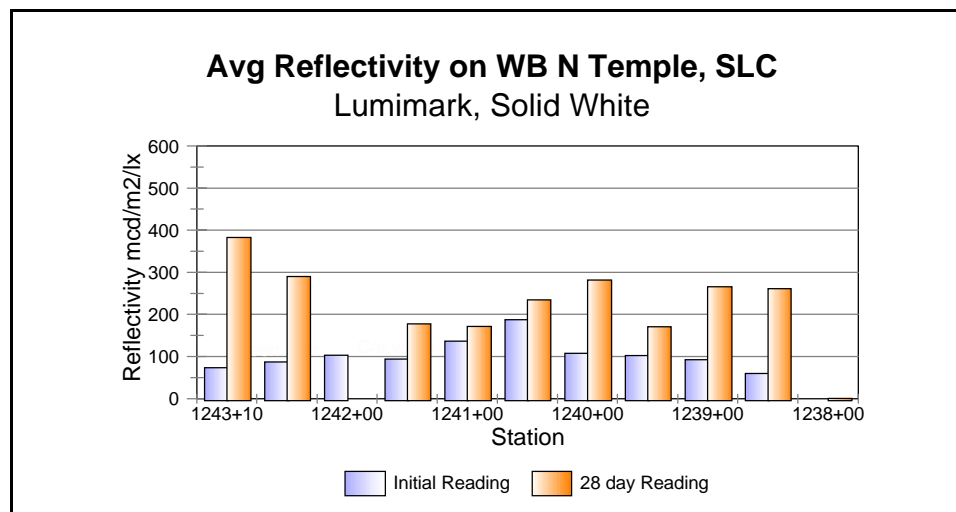
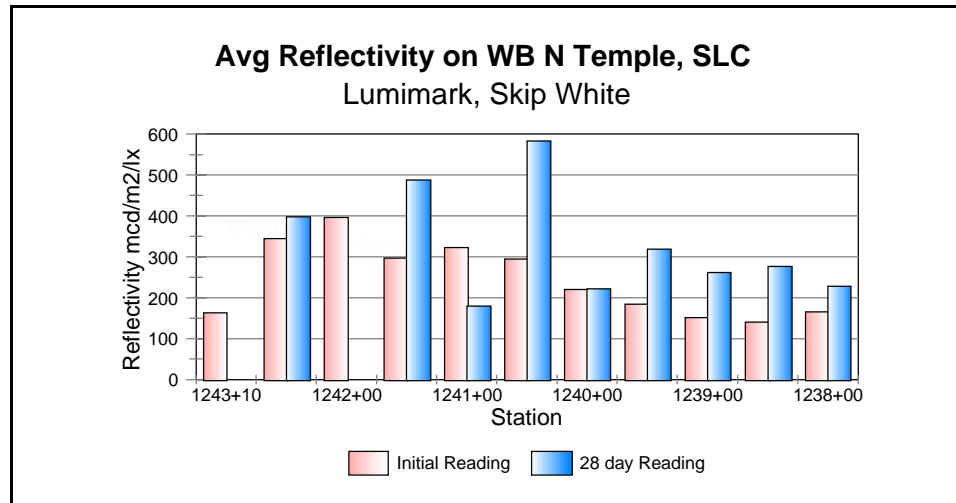
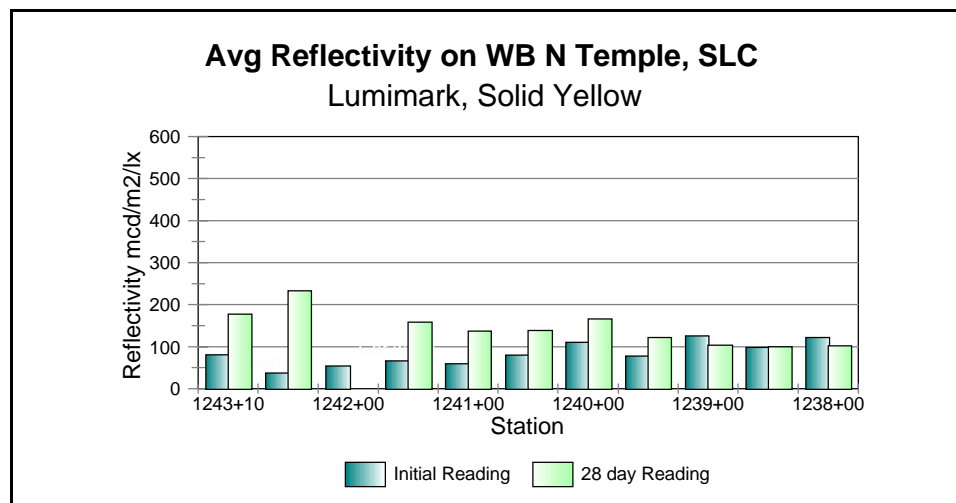
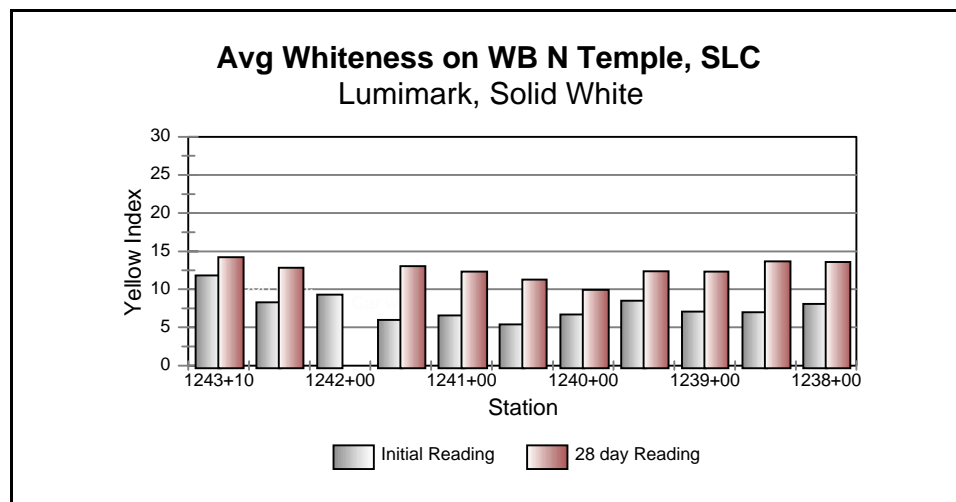
As indicated in the Work Plan, field data readings were taken immediately following, and 28 days after product installation. UDOT Field data readings include retroreflectivity ($\text{mcd}/\text{m}^2/\text{lux}$, using an LTL 2000 Retrometer, by Delta) and yellowness index (using a MiniScan Spectrocolorometer, by Hunter). Although the retroreflectivity readings after installation were not as high as what has been observed in new installations of competing traffic markings, following 28 days of being exposed to traffic, a considerable increase in retroreflectivity was observed. While the average retroreflectivity reading on the white skip line was around $244 \text{ mcd}/\text{m}^2/\text{lux}$ after installation, the same parameter rose to $328 \text{ mcd}/\text{m}^2/\text{lux}$ just 28 days after installation (an increase of about 35%).

The solid yellow line showed a 74% increase in retroreflectivity (from an average of $83 \text{ mcd}/\text{m}^2/\text{lux}$ to $144 \text{ mcd}/\text{m}^2/\text{lux}$). The most significant increase, however, was observed on the white solid line, from an average retroreflectivity value of $100 \text{ mcd}/\text{m}^2/\text{lux}$ to $240 \text{ mcd}/\text{m}^2/\text{lux}$, for a increase of 140% reflectance. This contrast seems to imply that wear on the marking surface from weaving cars may actually have a refreshing effect on the glass beads held within the material matrix. The following charts illustrate the findings presented herein (raw data can be found in the Appendix in tabulated form):

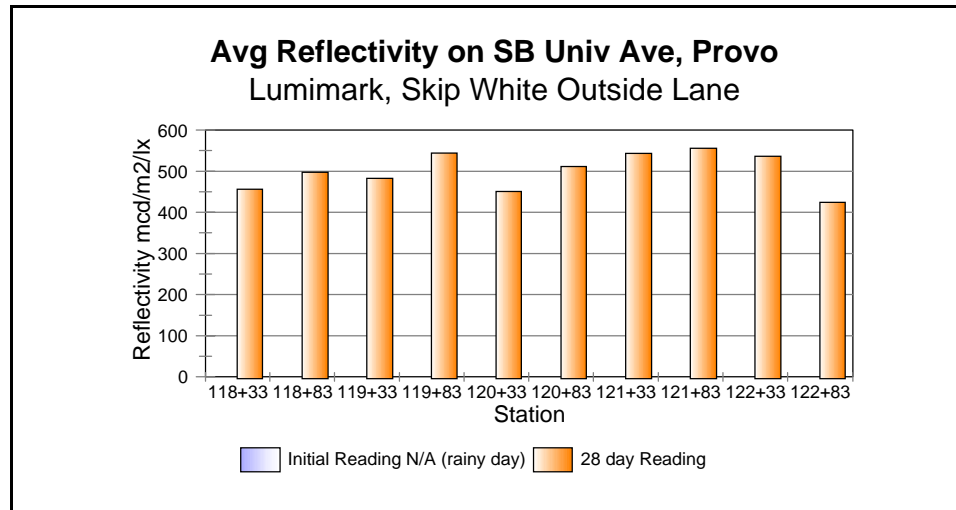
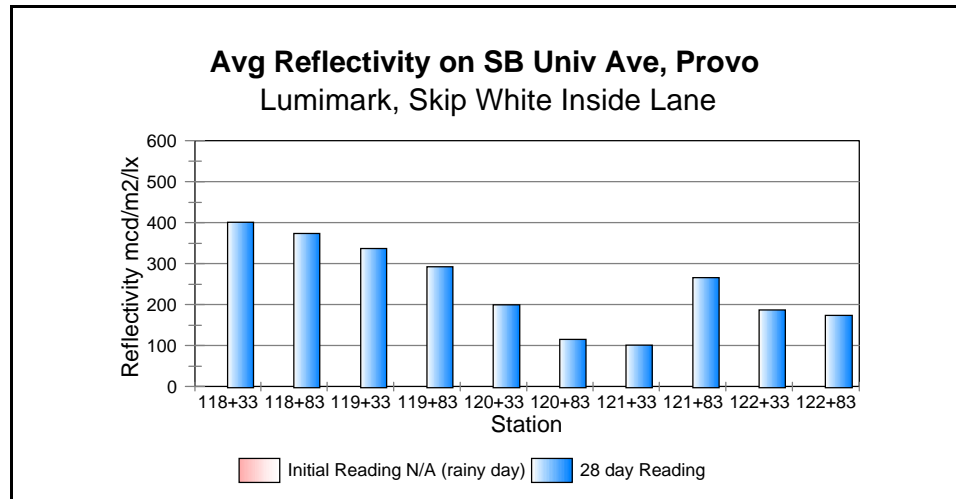
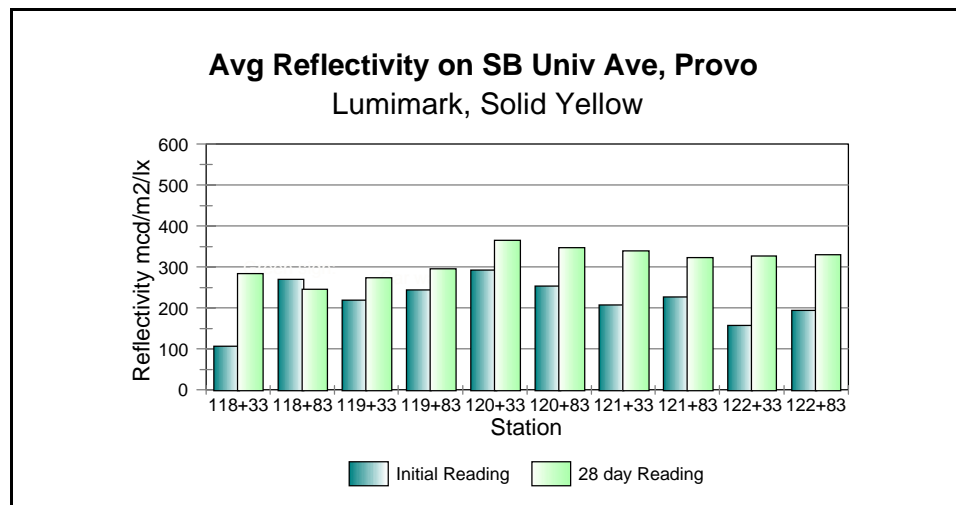
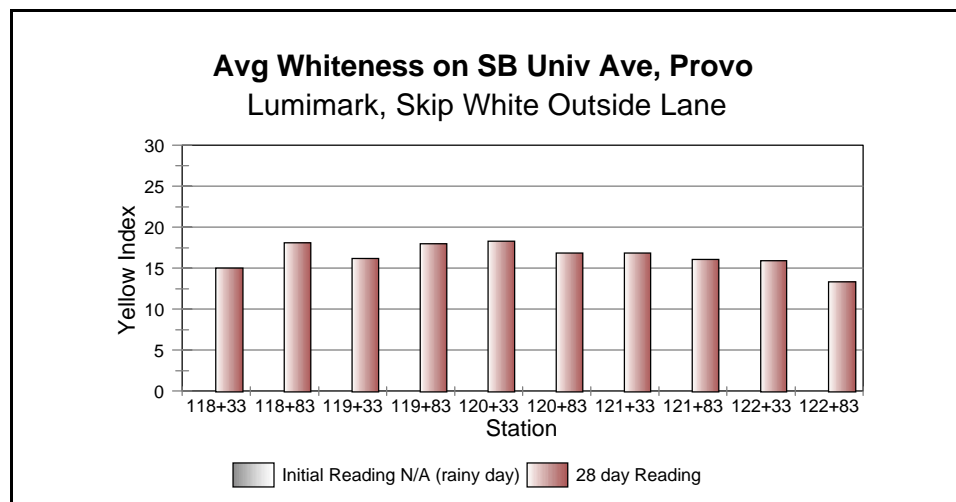
In accordance to the Work Plan, there were several attempts to obtain field data readings immediately following, and 28 days after product installation. As it was indicated earlier, product installation in Region Three took place under rainy conditions (both skip white and solid white were installed during the second placement night where it rained throughout the night into the early morning; see Figures 6 through 8). As a result of the prevailing weather, minor adjustments were made to the mix to prompt faster cure time, which made the material slightly less workable. This is somewhat evident by the rougher appearance of the finished product. Lingering rain did not allow for any retroreflectivity readings immediately after product cure (as a wet surface greatly distorts the readings obtained by the instrument). Therefore, the only retroreflectivity data available for comparison between immediate installation and 28 days after installation is the solid yellow line. As before, after 28 days of traffic, retroreflectivity values for solid yellow markings rose by almost 45%.
